**Flood Control Project Maintenance
Levee Inspections**

Maintenance Issue Types Only, Levee Inspection Report By Mile - Spring 2018

Sutter Maintenance Yard East Levee Sutter Bypass

Waterway	Bank	Unit Miles	Inspection Start/End	Inspector
Unit No. 01 Sutter Bypass Levee	Left	21.68	03/27/2018 03/27/2018	Bob Duffey

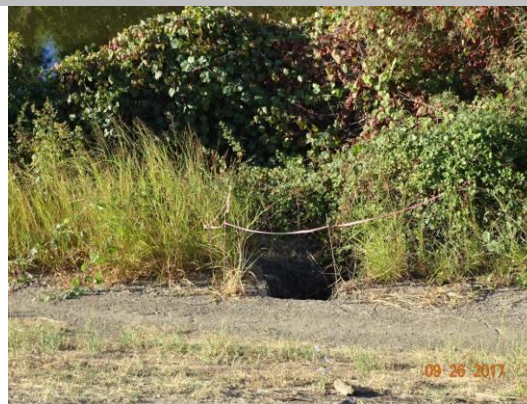
Photo 1 of 1 : SP_2018_ST0002_450_57_20180305_00013.jpg

LM Start	1.53	Rating **	U	Issue No.	57
LM End	1.53	Issue Type +	Ma	Location *	WS
Category	Earthen Levee			GPS Latitude/Longitude	
				Start	End
Item	Erosion / Bank Caving			39.137373 °	39.137373 °
				-121.810382 °	-121.810382 °
DWR ID	DWR_ST0002_01_f_2017_57				
Comment Code					
E2 : Schedule repair of erosion site prior to the next inspection.					
Inspector Comment					
Repair the beaver hole along the waterside berm.

View of the beaver hole along the waterside berm.

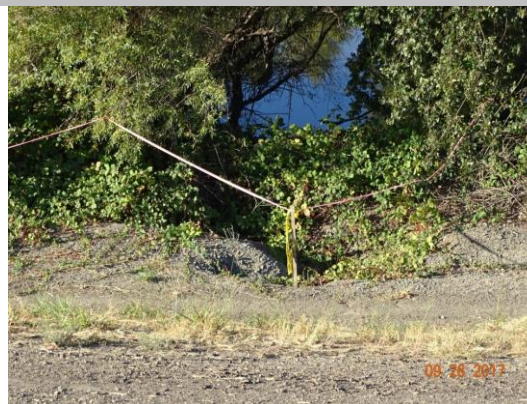
Photo 1 of 1 : SP_2018_ST0002_450_58_20180305_00014.jpg

LM Start	1.57	Rating **	U	Issue No.	58
LM End	1.57	Issue Type +	Ma	Location *	WS
Category	Earthen Levee			GPS Latitude/Longitude	
				Start	End
Item	Erosion / Bank Caving			39.137010 °	39.137010 °
				-121.809673 °	-121.809673 °
DWR ID	DWR_ST0002_01_f_2017_58				
Comment Code					
E2 : Schedule repair of erosion site prior to the next inspection.					
Inspector Comment					
Repair the beaver hole along the waterside berm.

View of the beaver hole along the waterside berm.

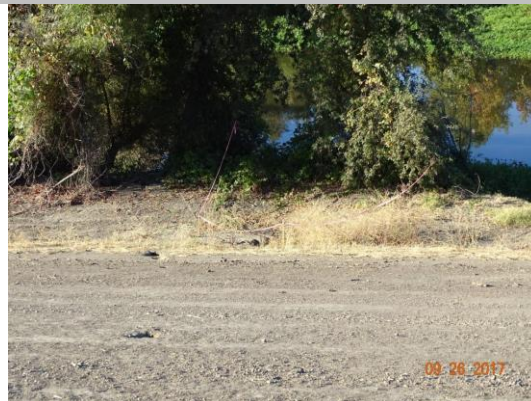
Photo 1 of 1 : SP_2018_ST0002_450_61_20180305_00015.jpg

LM Start	1.61	Rating **	U	Issue No.	61
LM End	1.61	Issue Type +	Ma	Location *	WS
Category	Earthen Levee			GPS Latitude/Longitude	
				Start	End
Item	Erosion / Bank Caving			39.136713 °	39.136713 °
				-121.809202 °	-121.809202 °
DWR ID	DWR_ST0002_01_f_2017_61				
Comment Code					
E2 : Schedule repair of erosion site prior to the next inspection.					
Inspector Comment					
Repair the beaver hole along the waterside berm.

View of the beaver hole along the waterside berm.

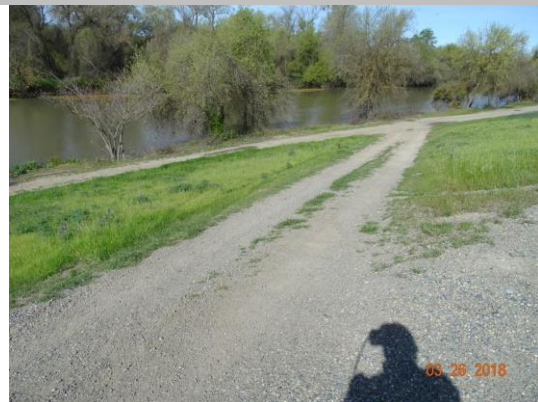
Photo 1 of 1 : SP_2018_ST0002_450_45_20180403_00076.jpg

LM Start	5.19	Rating **	M	Issue No.	45
LM End	5.19	Issue Type +	Ma	Location *	WS
Category	Earthen Levee			GPS Latitude/Longitude	
				Start	End
Item	Slope Stability			39.103368 °	39.103368 °
				-121.758760 °	-121.758760 °
DWR ID	DWR ST0002 01 s 2018 45

View of the vehicle traffic along the waterside slope.

Repair the slope damaged by vehicle traffic.

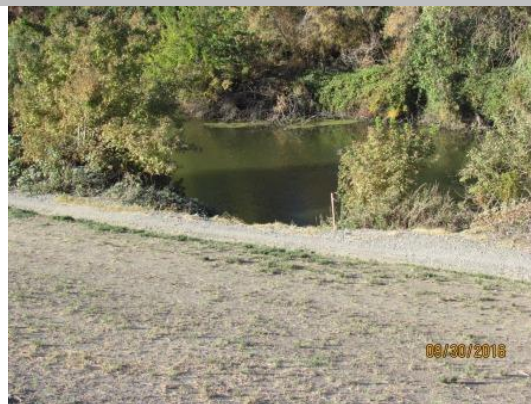
Photo 1 of 1 : SP_2018_ST0002_450_34_20180305_00008.jpg

LM Start	7.83	Rating **	A/W	Issue No.	34
LM End	7.83	Issue Type +	Ma	Location *	WS
Category	Earthen Levee			GPS Latitude/Longitude	
				Start	End
Item	Erosion / Bank Caving			39.067299 °	39.067299 °
				-121.742851 °	-121.742851 °
DWR ID	DWR_ST0002_01_f_2016_34				
Comment Code					
E1 : Note and monitor erosion site.					
Inspector Comment

View of the erosion along the waterside toe.

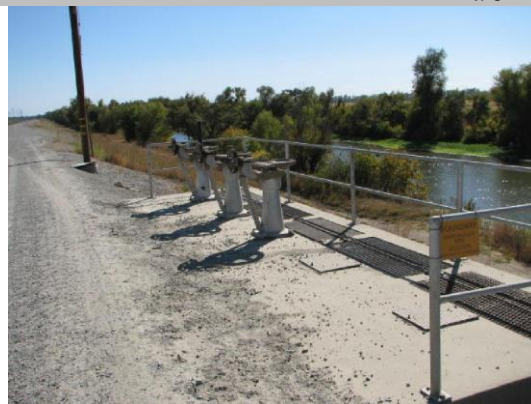
Photo 1 of 3 : UCIP_SP_2018_51595_65251.jpg

Comment Code						
Inspector Comment						
FS_ID:51595 DS_ID:16871 EP_NO: N/A Repair Type: Non-Urgent Crossing Status: Found UCIP Comments: 4/11/2017 Aabandoned.10/10/2016 Abandoned crossing.4/18/2016 Abandoned crossing but no noticeable issues seen with it.5/7/2015 Abandoned crossing but no noticebale issues with it.11/12/2014 Same as last inspection.5/13/2014 Same as last inspection.10/30/2013 Same as last inspection.5/22/2013 Same as last inspection.10/8/2012 Need to determine type of abandonment. FIELD_STRUCT_DESC: *ABANDONED* [Pumping Plant No. 2] 1 of 5: 48-inch by 72-inch reinforced concrete drainage culvert through the levee, 31.5 feet below the crown. Wood flap gate and concrete headwall on the waterside (WS) end. Wooden steps on the landside (LS) slope. Concrete steps on the WS end. [Additional Reference(s): DWR Levee Log, 2005. USACE Sacramento O&M Manual 315, May 1953 (Station 582+19)]. FS Date: 4/13/2017 2:16:54 PM

Slide gates on WS shoulder

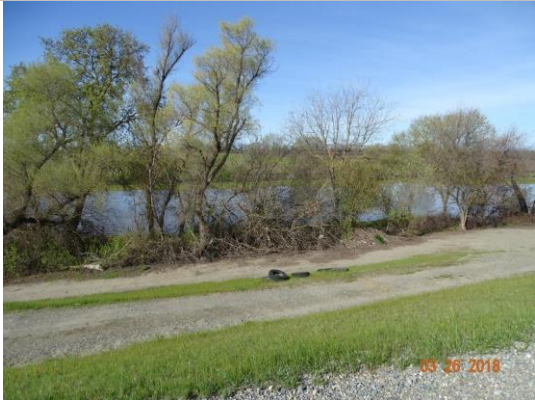
Photo 1 of 1 : SP_2018_ST0002_450_44_20180403_00075.jpg

View of the tires along the waterside slope and toe.

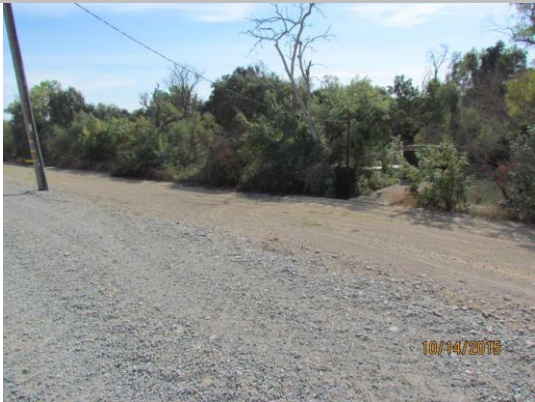
Photo 1 of 1 : SP_2018_ST0002_450_23_20180305_00004.jpg

View of the vehicle erosion along the slope.

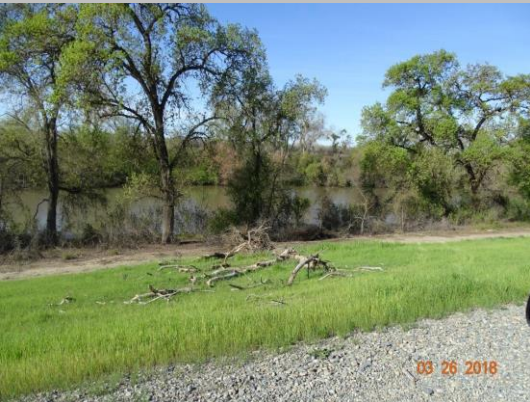
Photo 1 of 1 : SP_2018_ST0002_450_39_20180403_00074.jpg

View of the tree along the waterside slope and toe.

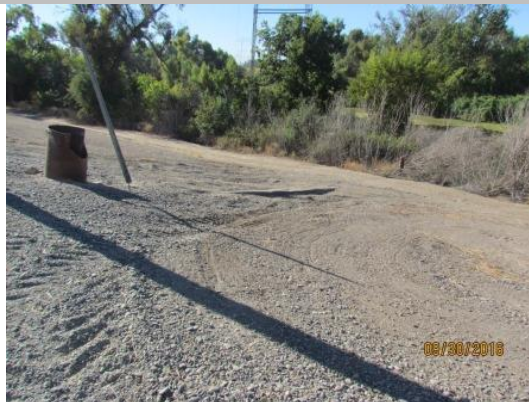
Photo 1 of 1 : SP_2018_ST0002_450_37_20180305_00009.jpg

LM Start	14.71	Rating **	M	Issue No.	37
LM End	14.71	Issue Type +	Ma	Location *	WS
Category	Earthen Levee			GPS Latitude/Longitude	
				Start	End
Item	Slope Stability			38.979389 °	38.979389 °
				-121.691923 °	-121.691923 °
DWR ID	DWR_ST0002_01_f_2016_37				
Comment Code					
S3 : Repair the levee slope damaged by vehicle traffic and prevent access where possible.					
Inspector Comment					
Repair the vehicle erosion along the waterside slope.

View of the erosion caused by vehicle traffic.

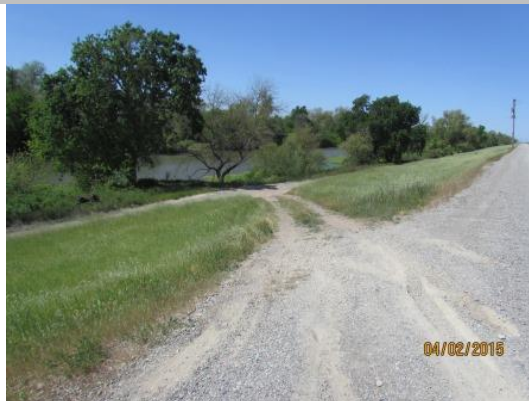
Photo 1 of 2 : SP_2018_ST0002_450_21_20180305_00002.jpg

LM Start	17.60	Rating **	M	Issue No.	21
LM End	17.60	Issue Type +	Ma	Location *	WS
Category	Earthen Levee			GPS Latitude/Longitude	
				Start	End
Item	Slope Stability			38.949965 °	38.949965 °
				-121.653823 °	-121.653823 °
DWR ID	DWR_ST0002_01_s_2015_21				
Comment Code					
S3 : Repair the levee slope damaged by vehicle traffic and prevent access where possible.					
Inspector Comment					
Repair the vehicle erosion along the waterside slope.

View of the vehicle erosion along the waterside slope.

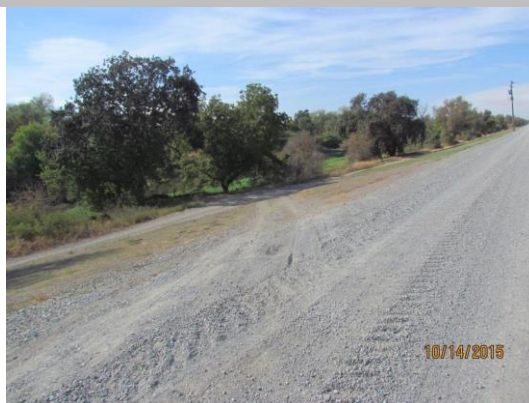
Photo 2 of 2 : SP_2018_ST0002_450_21_20180305_00003.jpg

LM Start	17.60	Rating **	M	Issue No.	21 (cont)
LM End	17.60	Issue Type +	Ma	Location *	WS

View of the vehicle erosion along the waterside slope.

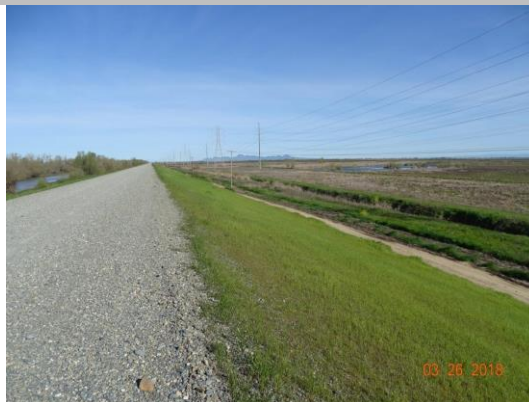
Photo 1 of 1 : SP_2018_ST0002_450_36_20180403_00072.jpg

LM Start	18.18	Rating **	A	Issue No.	36
LM End	18.18	Issue Type +	Ma	Location *	LS
Category	Earthen Levee			GPS Latitude/Longitude	
				Start	End
Item	Vegetation			38.943558 °	38.943558 °
				-121.646885 °	-121.646885 °
DWR ID	DWR_ST0002_01_s_2018_36				
Comment Code					
V1 : Control annual grass and weeds on the levee slopes and easements.					
Inspector Comment					
Native vegetation on both slopes are well maintained.

View of native vegetation on both slopes.

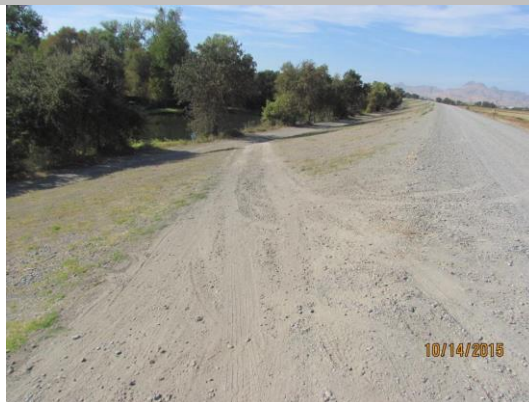
Photo 1 of 1 : SP_2018_ST0002_450_29_20180305_00006.jpg

LM Start	20.02	Rating **	M	Issue No.	29
LM End	20.02	Issue Type +	Ma	Location *	WS
Category	Earthen Levee			GPS Latitude/Longitude	
				Start	End
Item	Slope Stability			38.922678 °	38.922678 °
				-121.625890 °	-121.625890 °
DWR ID	DWR ST0002 01 f 2015 29

View of the vehicle erosion along the waterside slope.

S3 : Repair the levee slope damaged by vehicle traffic and prevent access where possible.
